Manhole Inspection Summary

Manhole # S19I__012MH

Location Address: **117 calverton st**

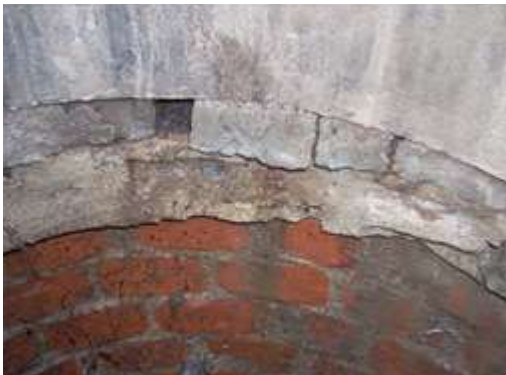
Defect 3

Condition: ☐ Sound ☒ **Cracked** ☐ Root Intrusion ☒ **Loose Brick** ☒ **Deteriorated**

Infiltration: ☐ None ☒ **Joint** ☐ Cracks ☐ Mortar ☐ Roots ☐ Wall

Cracked, loose bricks and infiltration in Chimney

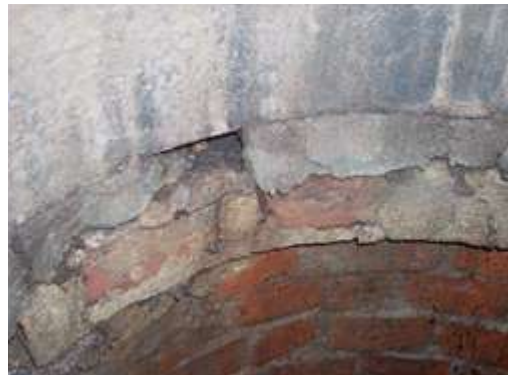
Defect 2

deteriorated chimney

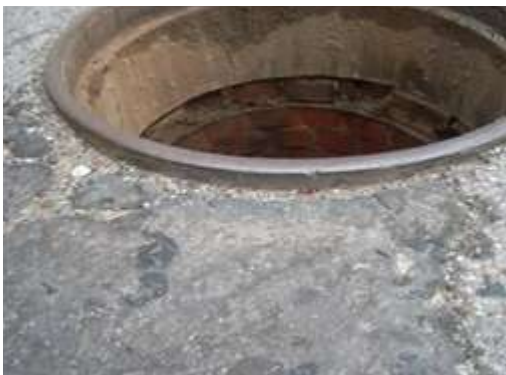
Defect 1

above grade

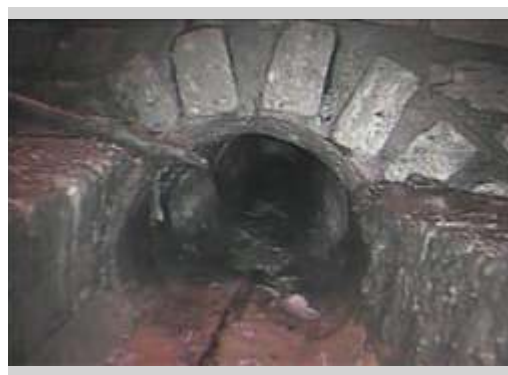
Defect

Condition: ☐ Sound ☐ Cracked ☐ Root Intrusion ☒ **Deteriorated** ☐ Leaks ☐ Debris

Bench Deteriorating

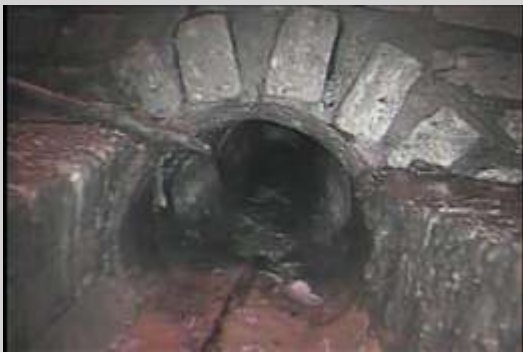
12 O'Clock Outflow

Pipe Height: **8.4** (in.) Rod and Bar (Angled)
Pipe Material: **Clay** ☐ Pipe Lined
Invert Depth: **11.87** (ft.) Flow Characteristics: **Slow**
Deposits: ☒ None ☐ Mud ☐ Sludge ☐ Debris ☐ Grease
Silt Depth: **0** (in.) Deposits Extent:
Infiltration: **None** Pipe Seal Cond: **Broken**

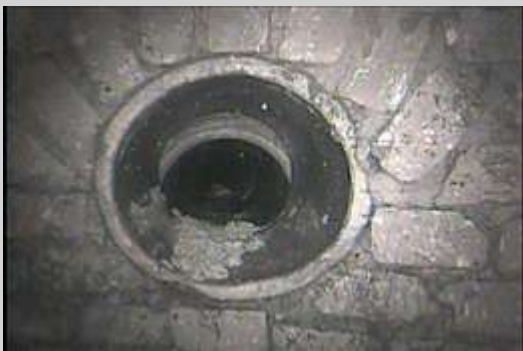
5 O'Clock Inflow

Pipe Height: **8.4** (in.) Rod and Bar (Angled)
Pipe Material: **Clay** ☐ Pipe Lined
Invert Depth: **8.71** (ft.) Flow Characteristics: **Fast**
Deposits: ☐ None ☐ Mud ☐ Sludge ☒ **Debris** ☐ Grease
Silt Depth: **1** (in.) Deposits Extent: **Light**
Infiltration: **None** Pipe Seal Cond: **Sound**

Drop: **Outside** Rod and Bar
Angled: **Yes** Reading: **10.58** (ft.)
Inv Depth: **11.58** (ft.)

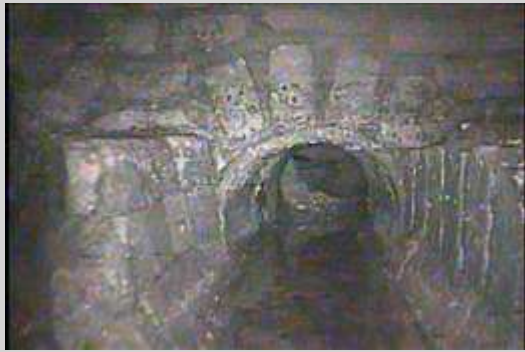
6 O'Clock Inflow

abandoned pipe

Connects To: **Stub connection / abandoned**
